**DEPARTMENT OF TRANSPORTATION**

**OBG BAY 14**

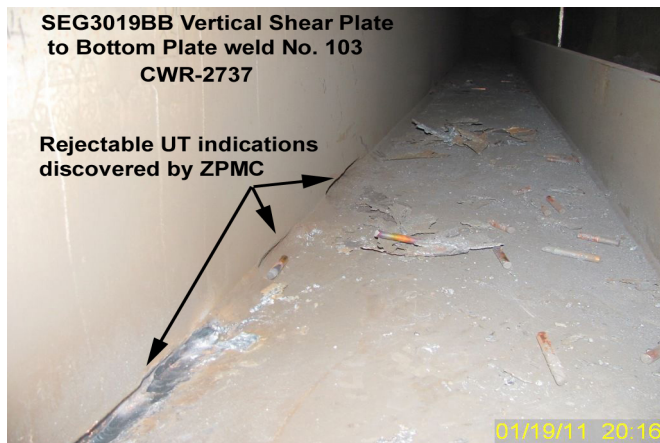
Unless otherwise noted, all work observed on this date appeared to generally comply with applicable contract documents.
